# **ADVANCED GAS TURBINE (AGT) TECHNOLOGY DEVELOPMENT PROJECT**

1985 ANNUAL REPORT  
(JULY 1984 — JUNE 1985)

Engineering Staff of  
Garrett Turbine Engine Company  
A Division of The Garrett Corporation

Prepared for  
NATIONAL AERONAUTICS AND SPACE ADMINISTRATION  
Lewis Research Center  
Cleveland, Ohio 44135  
Under Contract DEN3-167

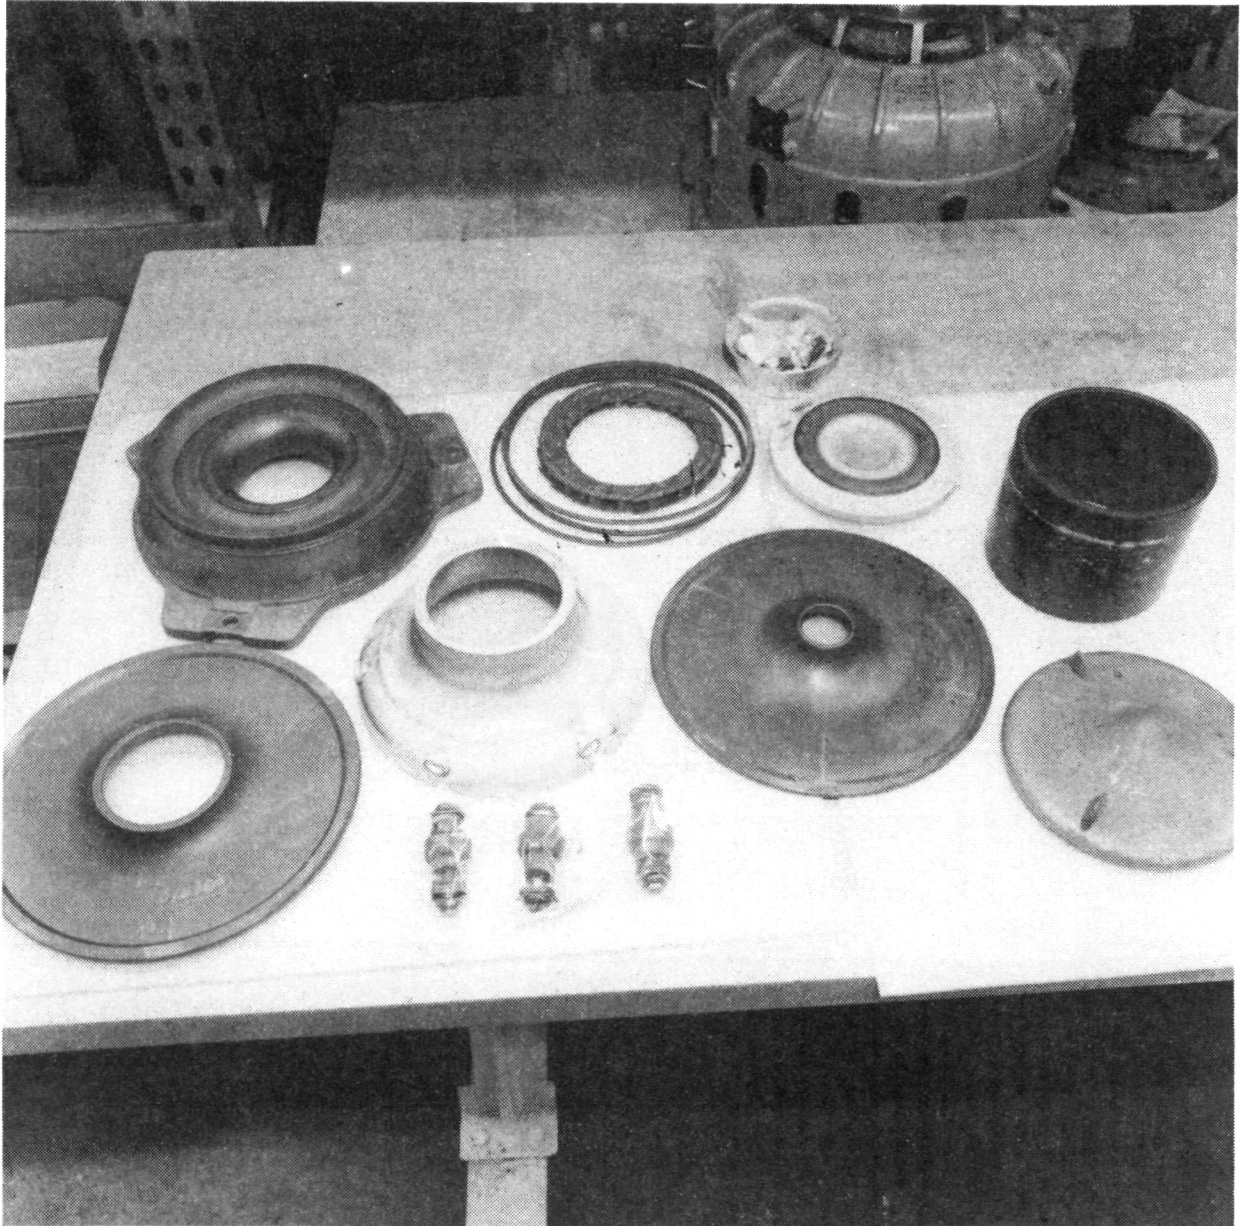
Figure 16. Ceramic Parts After 100 Hours at 2050  $\pm$ 50F and Cruise Speed.

The engine was subsequently torn down and all parts visually (30X) inspected. No cracks were found on any of the ceramic parts. Some minor chipping was noted on three stators and the piston ring seal. Figure 16 documents the excellent condition of the ceramic parts.
